# MEMORANDUM | EASTERN BRANCH JOHNS RIVER FECAL SOURCE TRACKING

**TO:** Christopher Hall Ph.D., Rachel Bizarro, Town of Bristol  
**FROM:** Forrest Bell, FB Environmental Associates (FBE)  
**SUBJECT:** Memorandum: Eastern Branch Johns River Fecal Source Tracking  
**DATE:** October 4, 2021  
**CC:** Margaret Mills, Maggie Kelly, FB Environmental Associates (FBE)

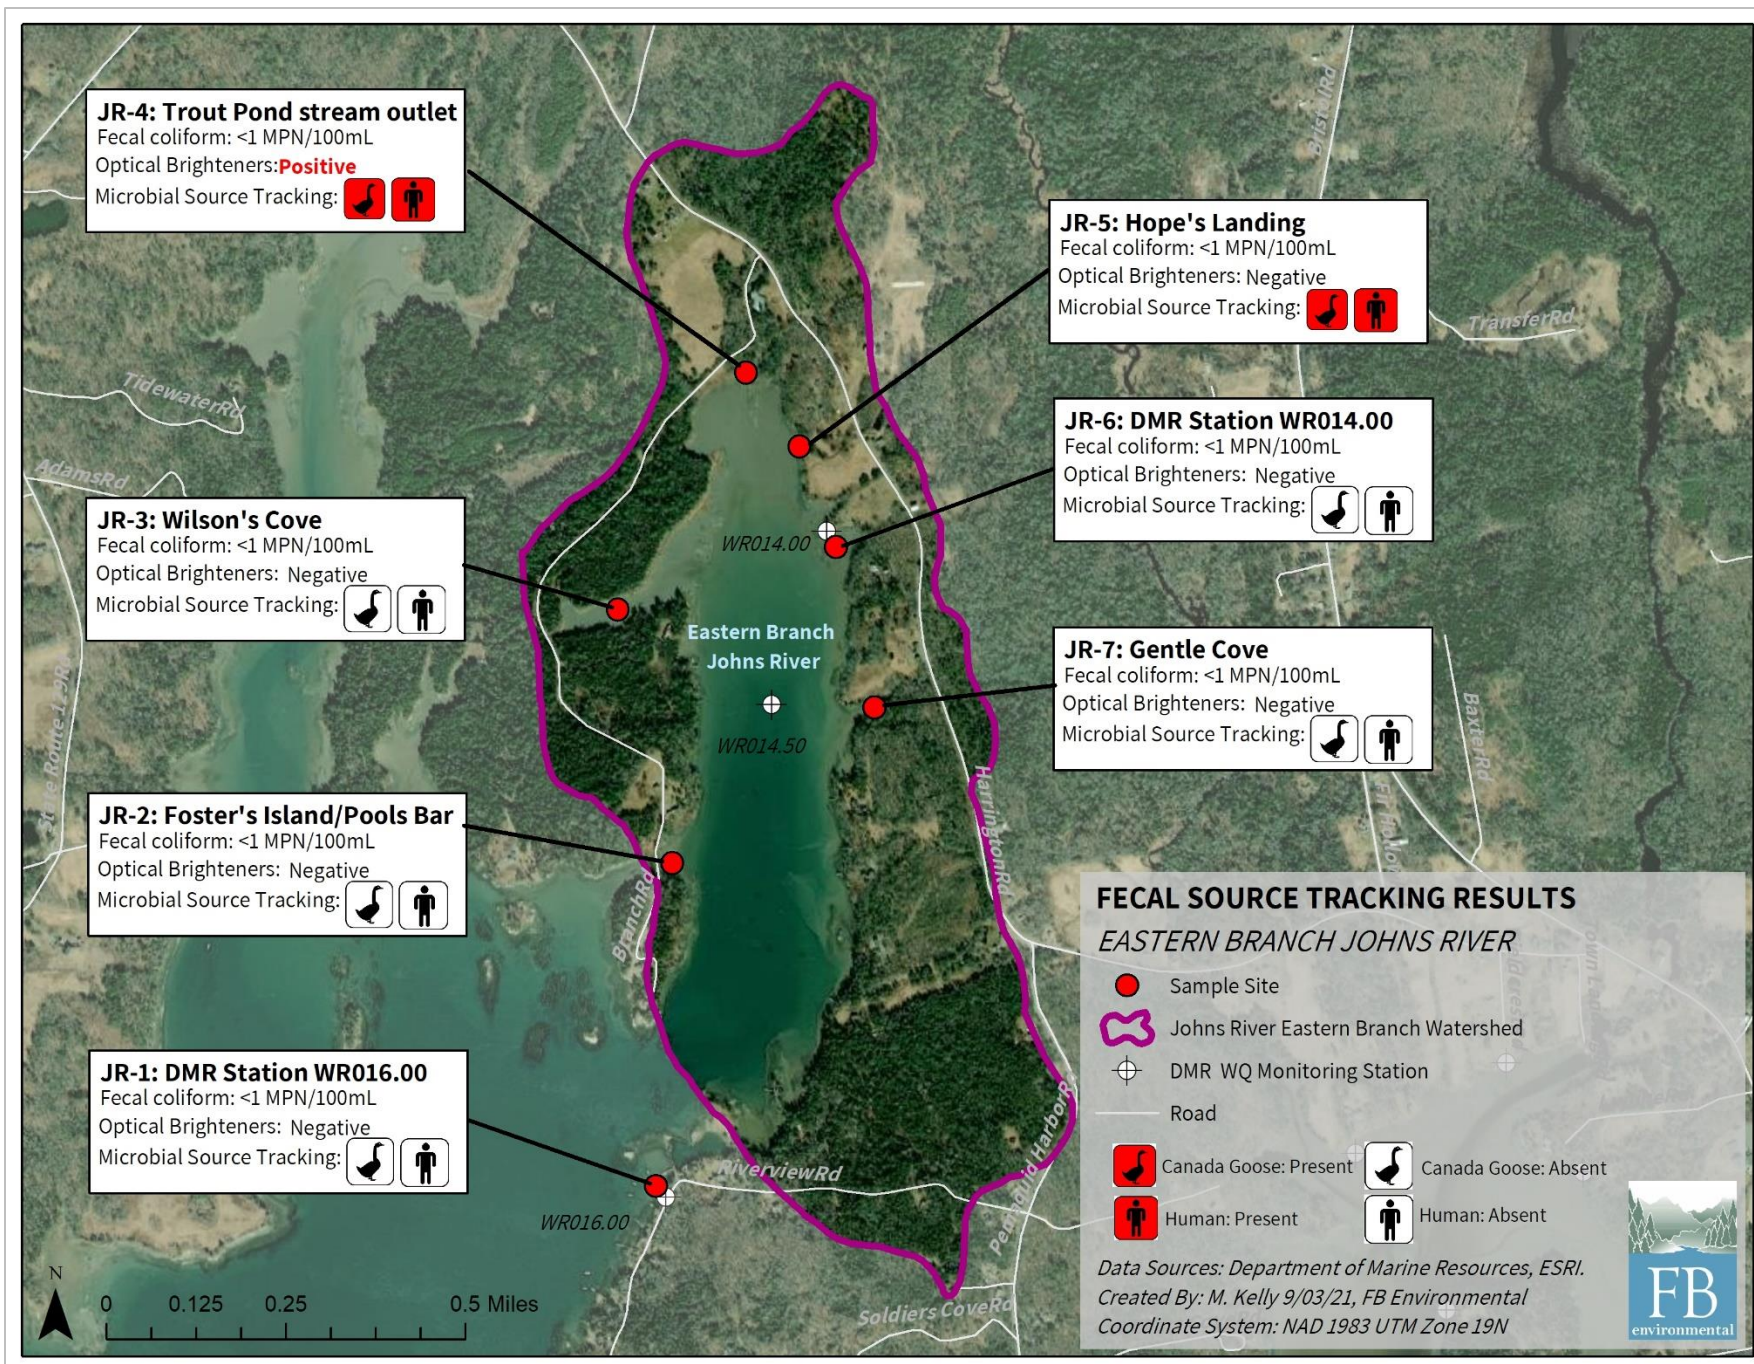
**Figure 1.** Results of fecal source tracking in the Eastern Branch Johns River.

Two of the seven sites had positive results for human and Canada Goose at low threshold concentrations. Sites JR-4 and JR-5 had low threshold concentrations of both markers, indicating that there is presence of fecal contamination from human and Canada Goose, but it is at low levels and resampling during both wet and dry weather conditions is recommended to get a stronger signal and understanding of the presence.

One site had a positive result for optical brighteners, site JR-4. Optical brighteners are commonly used for wastewater detection. Optical brighteners are not naturally occurring and are typically added to laundry soaps, detergents, cleaning agents, and toilet papers to aid in the brightening of fabrics and/or surfaces. Testing positive for optical brighteners in groundwater strongly suggests greywater from leach fields is entering the groundwater without adequate filtration. This indicates that there is a wastewater problem entering the estuary, potentially upstream of site JR-4.

- We recommend further microbial source sampling for human and Canada goose markers at sites JR-4 and JR-5 in the spring as snow is melting and during a precipitation event. John Bucci of the UNH Microbial Source Identification Laboratory recommends sampling during a rain event at higher flow and as the weather warms up, bacteria will be mobilized and provide a stronger signal. Further sampling could be done directly at the tributary outlets and upstream.

- Based on the positive results for optical brighteners above site JR-4 and for the human marker, we recommend investigating possible septic system malfunctions. To assist with this, we recommend performing bracket sampling on the intermittent stream at the top of estuary, referred to as the “Trout Pond” stream, during a wet weather event. This stream splits into two tributaries directly above the outlet to the estuary. Bracket sampling is a technique that assists in pinpointing sources of bacteria entering a tributary, done by sampling upgradient and downgradient of potential sources to isolate pollutant source locations.

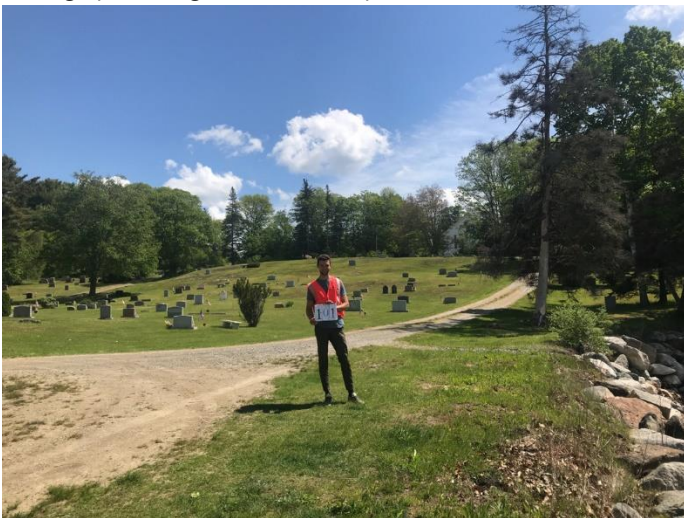
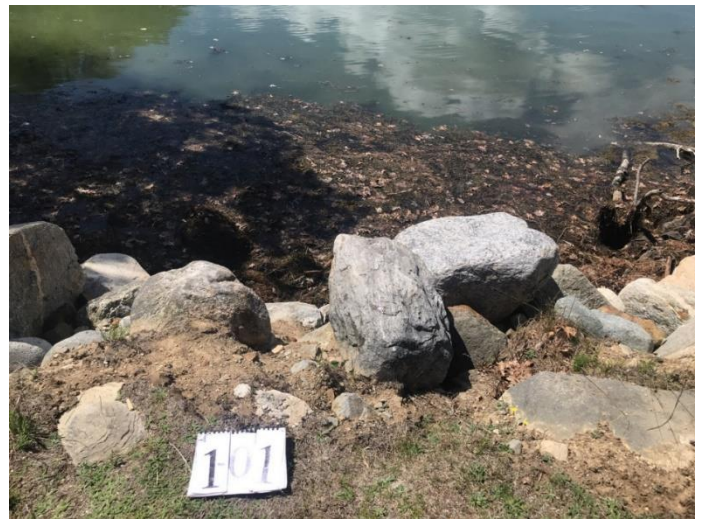
### (1) Harrington Cemetery

**OBSERVED POTENTIAL PROBLEMS:** The cemetery lawn is sloped to the edge of the cove, allowing runoff and possibly pollutants to enter the estuary. The shoreline lacks a vegetated buffer for approximately 105 feet along the water. The shoreline has been armored with boulders, presumably to stop an ongoing erosion problem. The shoreline edge above the stones is eroding into the water. An infiltration trench also leads directly to the water, which may slow and infiltrate some runoff.

The slope of the cemetery lawn and lack of buffer along the shoreline may allow pet waste, fertilizer, or waterfowl waste to enter the estuary. Although there were no signs of Canada Geese during the survey in June 2021, local clammers have noted significant congregations of geese at the cemetery.

*Harrington Cemetery slopes towards the shoreline. Approximately 105 feet along the shoreline is unbuffered (left), allowing pollutants to enter the water. The armoring along the water is eroded at the top of the bank (right), indicated that runoff enters the water here, potentially carrying bacteria or other pollutants.*

**RECOMMENDATIONS:** We recommend installing an extensive vegetated buffer (25 of width where possible) along the bare 100 feet of shoreline. FB Environmental can help Bristol design and implement this buffer. This buffer will slow runoff and filter pollutants before they enter the water. Vegetation and tall grass will also discourage geese from landing on the lawn next to the water, reducing potential risk of waterfowl waste. We also recommend installing signage and/or waste bags to encourage pet owners to clean up pet waste. Lastly, installing stairs on the point of the cemetery where people climb down the bank to the water could reduce erosion through providing a clear access point.

- We recommend working with the agency in charge of Harrington Cemetery to improve the buffer along the shoreline. We recommend a 25 foot wide buffer (where possible) of shrubs and plants to capture pollutants before entering the water and infiltrate stormwater. It will also discourage geese from landing on the grass and entering the water.

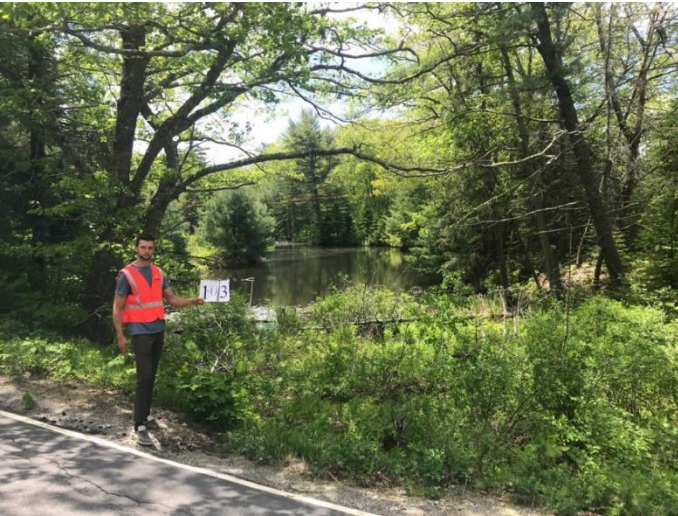
## (2) Pond adjacent to East Branch Road (“Trout Pond”)

**OBSERVED POTENTIAL PROBLEMS:** The manmade pond, termed the “Trout Pond” located on the corner of East Branch Road and Harrington Road has altered natural stream conditions. The pond is located approximately 500 feet upstream of the north tip the estuary. The water in the pond is stagnant, which may allow bacteria growth to occur and wash downstream. The inlet to the pond comes from a clogged culvert that crosses under Harrington Road. The outlet of the pond appears to be several large, black drainage pipes that come from the pond into the ravine, which then flows directly into the estuary (note: the land is private land, as such, FBE only viewed the pond and outlet from East Branch Road).

*Manmade pond at the corner of Harrington Road and East branch Road and East Branch Road.*

**RECOMMENDATIONS:** We recommend working with the pond’s owner to see when and how the pond outlets into the stream that leads to the cove. Future sampling below the pond may help determine if there are any pollutants of concern entering the stream from the pond. In addition, we recommend ensuring that there is an extensive buffer along the pond to discourage geese or other waterfowl from landing and entering the pond.

- We recommend working with the landowner of the Trout Pond to enhance the buffer along the edge of the pond to discourage geese from landing and entering the water. In addition, we recommend discussing with the landowner how the pond outlets.

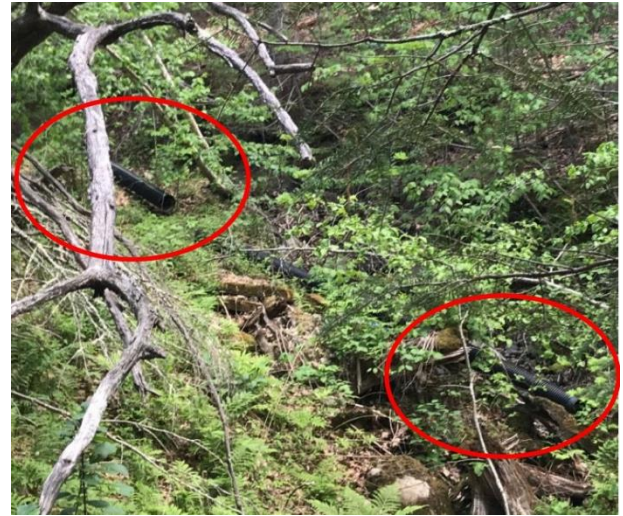
*Black drainage pipes, circled in red, coming out of pond and into the ravine that leads to the estuary.*

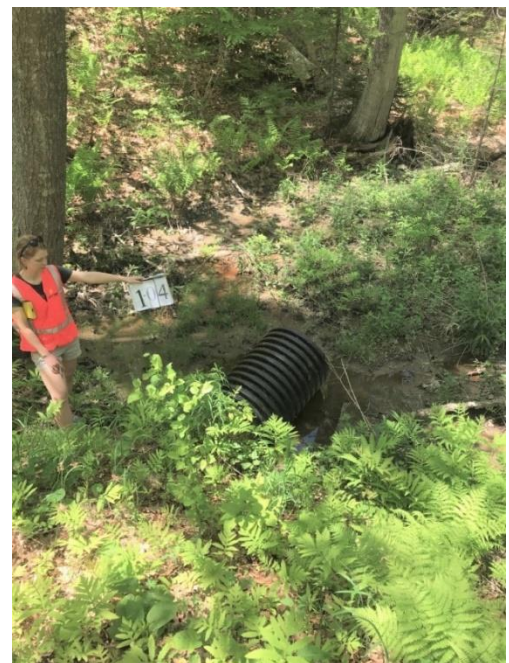
## (3) Ravine/drainage to Cove on East Branch Road

**OBSERVED POTENTIAL PROBLEMS:** The culvert that crosses under East Branch Road at the top of the estuary allows a small tributary to outlet into the stream that enters the northern tip of the Eastern Branch Johns River estuary. The culvert is misaligned, and the inlet of the culvert is perched, which appears to allow ponding to happen behind the culvert inlet. The culvert outlet is also extremely perched.

*Ponding is occurring below/behind the culvert inlet, causing the inlet to be perched and not drain properly.*

**RECOMMENDATIONS:** Replace or reinstall this culvert at grade to fix the perched inlet and outlet.
